# Ham Hum

June 12, 2020 Volume MCMXLV, Issue 6

#### THE TUNING OF A DUPLEXER

A Saga of Suspense, Intrigue, Discovery, and Accomplishment

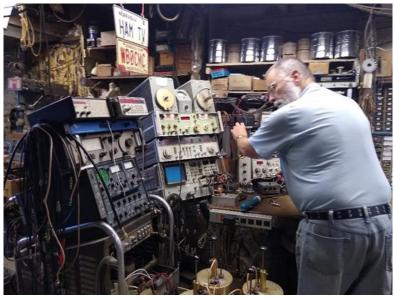
While troubleshooting a noise issue on the 146.82 SWIARC repeater it was determined that the duplexer needed to be serviced. John WB0CMC volunteered to look it over if it were transported to his workbench. Anxious to take advantage of this generous offer, the duplexer was removed from the 82 site and conveyed to John's inner sanctum. You can see the duplexer set at the bottom center of photo 'A'.

Photo 'A' - John WB0CMC at his workbench. SWIARC duplexer visible at bottom center of photo.

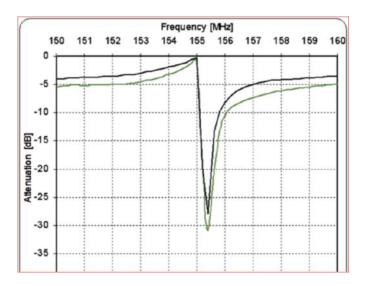
A word here about the type of duplexer we are working on for this article. It is a Band-Pass / Band-Reject style duplexer. It usually consists of two cavities in both the transmit and receive leg tuned to pass one frequency and notch, or reject, the other frequency. The transmit leg is tuned to pass the transmit frequency and notch the receive frequency; while the receive leg tuned to pass the receive frequency and reject the transmit frequency. Illustration 'B' is a spectrum analyzer display of a typical single cavity band pass / band reject filter. The "band pass" portion of the cavity is tuned to 155 MHz and shows approximately a 1 dB insertion loss. The "band reject" portion of the same cavity shows either a 27 or a 32 dB insertion loss, depending on which curve you are looking at.

Illustration 'B' - A spectrum analyzer display of a <u>typical single cavity</u> band pass / band reject filter.

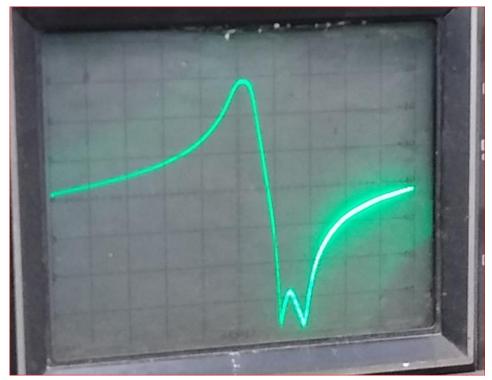
Photo 'C' shows the curve of the SWIARC duplexer receive leg as it was when we started. ..Note the double notch on the right.

The peak on the left is the 146.22 receiver frequency that is passed through from the antenna port to the repeater receiver. The double notch on the right is supposed to be a single notch tuned to the 146.82 transmitter frequency. Each major graticule division is 10 dB, so the two notches are only about 66 dB down. The specification for this duplexer is 80 dB. The double notch occurs because the notch tuning on the two cavities don't match. Each is notching at a slightly different frequency.

At this point, the duplexer was re-tuned to factory specifications or better. The transmit leg measured about 1.2 dB insertion loss on 146.82 MHz with a notch of -85 dB of rejection on 146.22 MHz. The receive leg measured about 1.4 dB insertion loss on 146.22 MHz with a notch of -83 dB of rejection on 146.82 MHz.

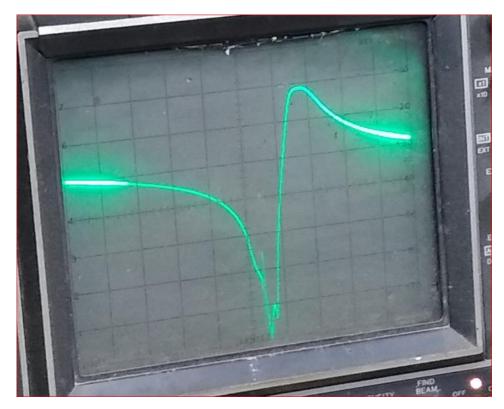
Photo 'D' shows the curve of the SWIARC duplexer transmit leg as it was when we started.....Note the abnormal notch on the left.

The little upward spike seen within the notch dip is the external marker generator used to mark the 146.22 MHz frequency within the display (labeled 146.22 MARKER in the photo). Again, you can see the double notch where the two duplexer cavities' notch filters are not tuned to the same frequency. In fact, neither of the two notches are on the 146.22 frequency. 146.22 MHz is only about -55 dB instead of the -80 dB spec.

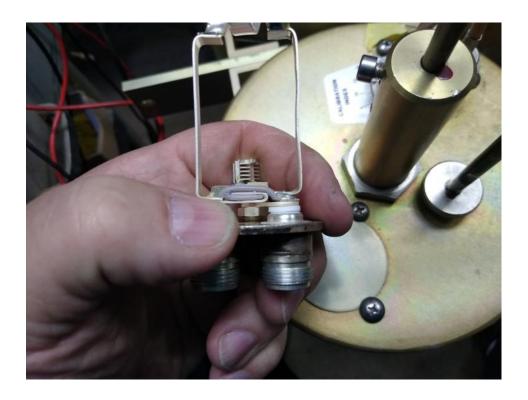
When the first insertion loop was removed and inspected under magnification it was discovered that the capacitor across the terminals was positioned extremely close to the metal strap. The capacitor being discussed is the 'Z' shaped component with the gray plastic material separating the metal plates. The bottom of that component is positioned with no discernable clearance to the naked eye. It is so close that a piece of paper wouldn't fit in between them. See photo 'E'.

Photo 'E' – This photo shows the insertion loop with the Z-shaped capacitor almost touching the strap. ..No space between them can be seen. The small trimming capacitor behind it is the notch adjustment.

Some minor physical tweaking increased the space from the bottom of the capacitor to approximately 1/32". There was also an extremely small solder splash inside the loop that was removed. Photo 'F' shows one of these insertion loops after it has been adjusted. The space between the bottom of the capacitor and the strap can now clearly be seen. The insertion loop was then re-installed into the cavity.

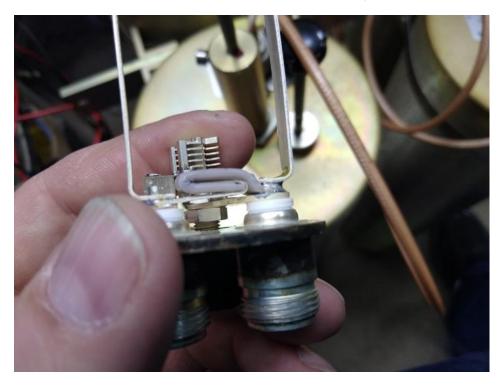
Photo 'F' - The space between the bottom of the 'Z' shaped capacitor and the strap can now clearly be seen

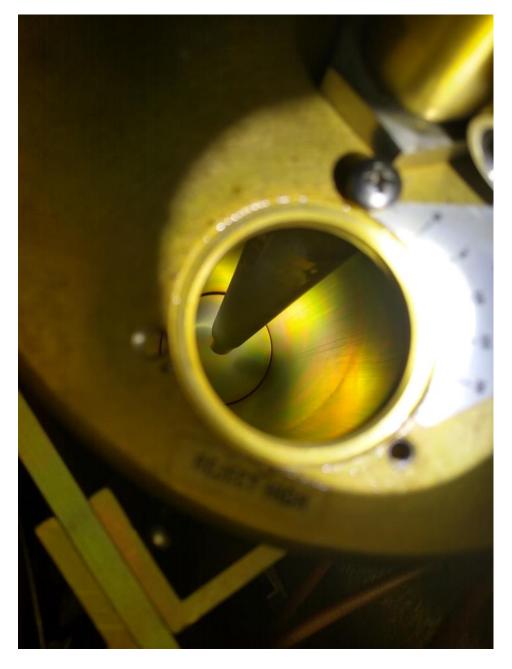
For those that have always wondered what the inside of one of these cavities looks like, photo 'G' page 9 is a view of the inside of a cavity that was visible with the insertion loop removed. There is a shorter tuning rod the is not visible in this photo as its view is blocked by the large tuning rod seen here.

Photo G (Inside view of duplexer cavity)
